A study on environmental corrosion of gilded heritage structures of Royal Palace Patan, Nepal

This article presents the results of corrosion study carried out on 17th century gilded sample procured from the metallic golden window of Patan Royal Palace, Nepal. The characterization techniques employed in the study provide the detailed information about the environmental pollutants responsible for the corrosion and degradation of gilded window. The analytical results have revealed that the window has been made of pure copper sheet on which traditional mercury-amalgam gilding technique has been used. Particulate matters like elemental carbon, sulphur dioxide, chlorine and organic matter have been found to be the main factors responsible for the corrosion and degradation of gilded surface. The information obtained from the present study is expected to be the source of understanding and solution for the protection and conservation of the gilded heritage of Nepal.

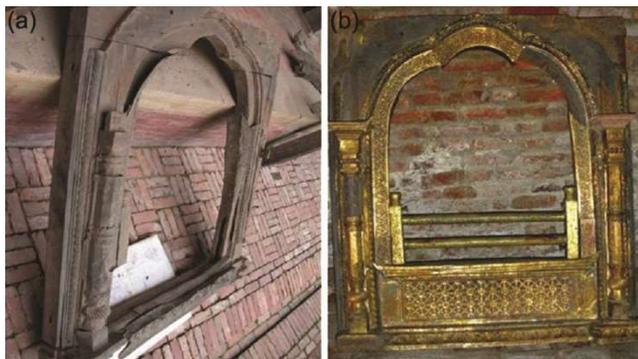
encrustations due to both products of metal corrosion and exogenous materials. Photos of before and after conservation of 17th century gilded window from Royal Palace Patan, Nepal is shown in Fig. 2. Today Nepal's mountainous and challenging topography and socio-economy make it a highly vulnerable country to climate change. Degradation to the environmental qualities in the valley is seriously hampering the national economy particularly the tourism sector and damaging these invaluable archeological and heritage site.

Fig. 2 — Photos of 17th century gilded window from Royal Palace Patan, Nepal (a) before and (b) after conservation.

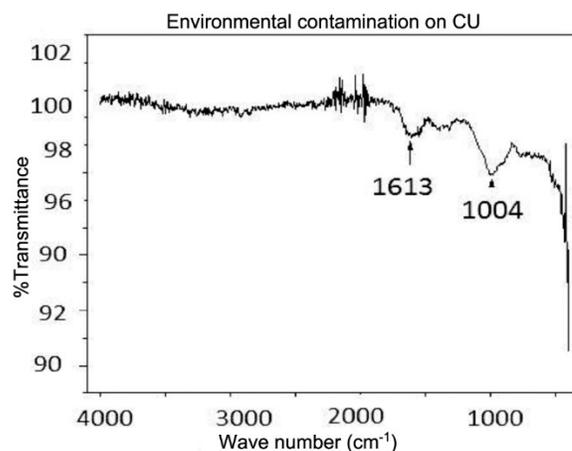
Fig. 5 — FTIR spectra of gilding sample showing C-C stretch and C-H bending.

Noise is observed in the data due to air gap. However, according to the standard IR frequency table, the peak at 1613 cm^{-1} corresponds to C-C stretch and peak at 1004 cm^{-1} corresponds to C-H bending on the surface of the sample. A little broadness can be seen in the higher side of wavenumber (i.e., $3500\text{--}3200\text{ cm}^{-1}$) which can be attributed to presence of moisture. Presence of large amount of carbonaceous material revealed in the SEM image and EDS spectra are confirmed by the existence of C-C stretch as depicted in FTIR spectra.

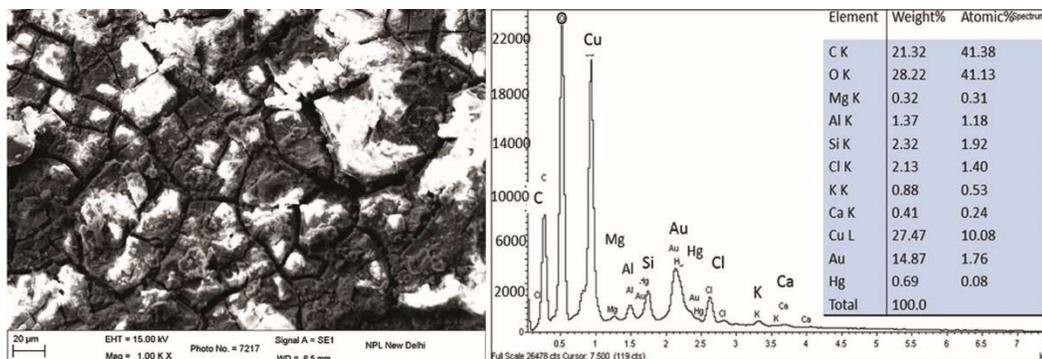
Scanning electron microscopy investigations can show the sample superficial texture at nanometric level, revealing shape and dimensions of particles that constitute the surface layer. Figure 4 represents the secondary electron (SE mode) SEM micrograph of the sample as procured from golden window of Patan Royal Palace, Nepal. The surface of the sample was not cleaned before putting into the scanning electron microscope (SEM) specimen chamber. SEM image revealed that the surface of the sample is composed of bright and some dark areas. The bright area in the micrograph represents the amount of dust particles containing carbonaceous compounds deposited as contaminants from the environment on the surface of the sample during the course of time. Large fraction of area of the sample consists of micro cracks throughout on the top surface of sample which may be developed

due to the exposure to varied atmospheric conditions over the years. As per the gilding process used in the Nepal in the ancient years are concerned, very thin layer of gold (Au) used to be deposited on copper sheets by a long and cumbersome gilding process⁷. Thickness of the Au gilding depends on the amount of Au available¹. This is further to mention here that the initiation of micro and nano cracks on the gilding surface may be created due to the variation in coefficient of thermal expansion of Cu ($16.6 \times 10^{-6} \text{ m}/(\text{mK})$), Au ($14 \times 10^{-6} \text{ m}/(\text{mK})$), and Hg ($61 \times 10^{-6} \text{ m}/(\text{mK})$). If the body is constrained so that it cannot expand, then internal stress will be caused or increased by an increase in temperature resulting in the localized stress and the strain at the gilding surface which are evident from the SEM image.

Fig. 4 — SEM micrograph of the gilding sample without cleaning its surface and EDS spectra.

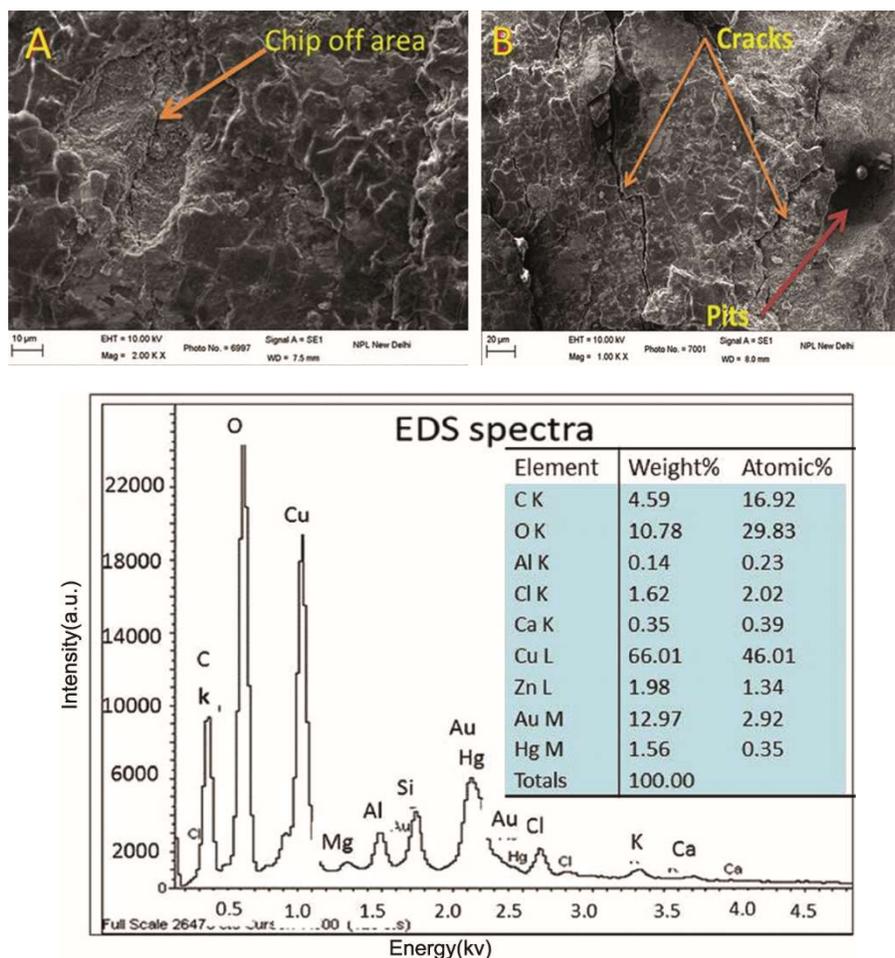
Prior to SEM imaging the same sample was cleaned in the acetone followed by the ultra-sonication to remove the environmental contaminants on the sample's surface. Images A and B shown in Fig. 6, represent the SE mode SEM micrographs of the cleaned gilded sample. SEM image marked as A shows the chipped off areas at certain places in the sample which may be due to the exposure to different atmospheric conditions during time. SEM image

marked as B revealed the presence of micro and nanocracks along with the evidence of pits at some places which are clearly indicated in the image. These pits may have been created due to the reaction of chloride or sulphate ions present in the environment as pollutant after forming the acids. The figure also shows the elemental compositional details of the corresponding areas of the sample.

Presence of various elements is depicted in the table shown as an inset of EDS pattern and also marked on the spectra peaks corresponding to different energies. Presence of elements like C, O, Si, Cl, Ca may be due to contaminants present in the atmosphere and the elements such as Mg, Al, K are expected due to the impurities in the copper sheet used for the gilding process. However, the presence of Au and trace amount of Hg proves that mercury-amalgam process was used in the making of golden window. This is further to be noticed here that the high amount of C in the EDS spectra still persists even after

Fig. 6 — SEM images (A and B) of the chip off area and the EDS spectra of the corresponding area of the cleaned sample.

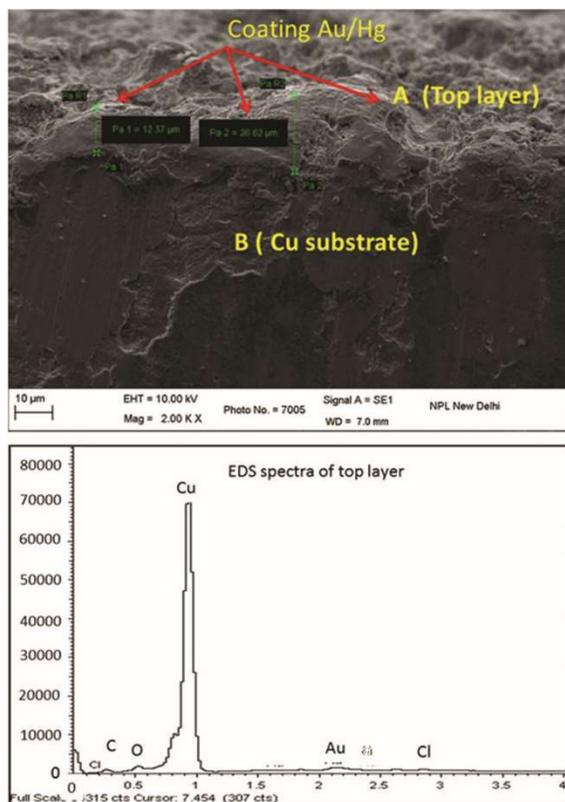
An effort has been made to identify the thickness and the uniformity of thin layer of Au coating during the gilding process (Fig. 7). Cross sectional SEM image as depicted in Fig. 8 clearly revealed that the gilding layer is not uniform. Thickness of the gilding layer is found to vary between 12 to 20 micrometers. Presence of Hg is not revealed in the EDS spectra (Fig. 7) as expected as per the traditional gilding technique in the Nepal is concerned, since the Hg was supposed to be sublimed during the repeated heat treatment.

Fig. 7 — SEM image of cross sectional view and the EDS spectra of same area.

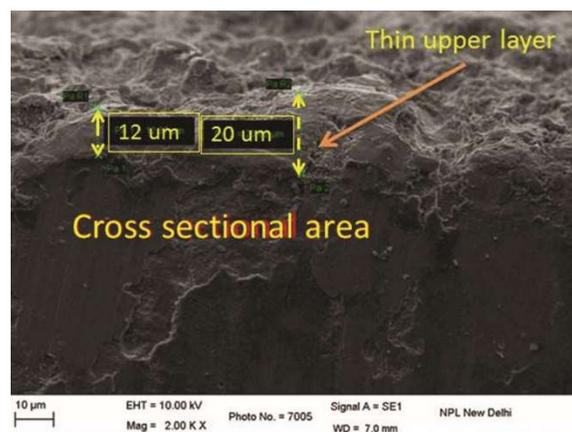
Fig. 8 — SEM image of cross sectional view of the sample indicating the variation in thickness.

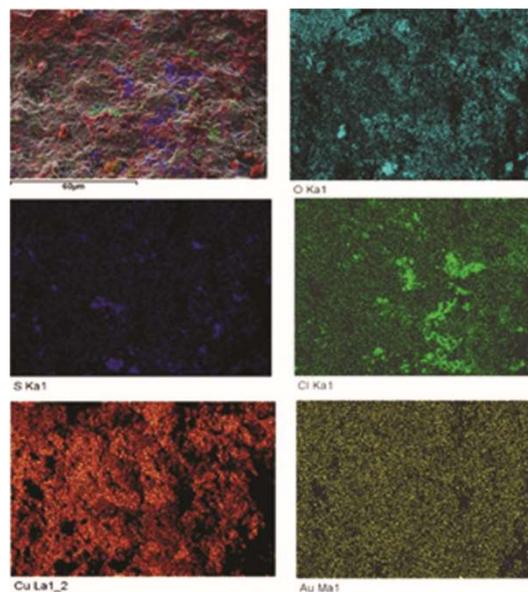
X-ray mapping of gilded sample is presented in Fig. 9. Distribution of various elements like oxygen, sulphur, chlorine, copper and gold has been revealed in the mapping originated from different energy levels of the element present in the sample. It is evident from

the X-ray mapping images that a sufficient amount of sulphur and chlorine is present on the top surface which is responsible for the initiation of corrosion and degradation (chipped off) of the gilded surface during the course of time.

Fig. 9 — X-ray mapping of gilding sample showing maps of different elements.

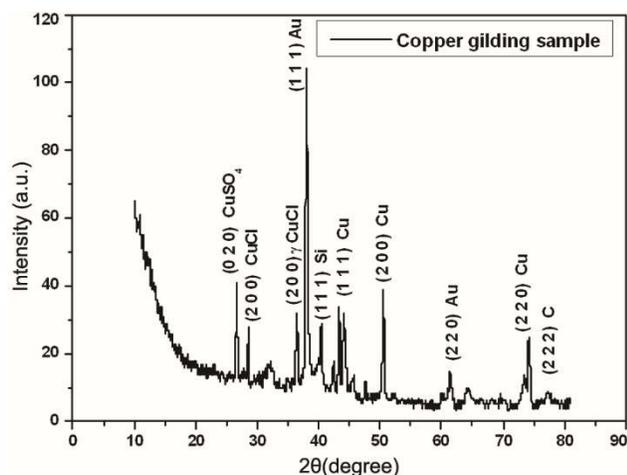
X-ray diffraction technique was used to further characterize the gilded sample for the identification of various elements and the different phases of the compounds present in the sample. A typical diffraction pattern of the gilded sample has been shown in Fig. 10. From the XRD data it is observed that the sample mainly composed of copper and gold present due to gilding process used in ancient times in Nepal. Diffraction peaks oriented along (111), (200), (220) direction found to be of copper matching with the

Fig. 10 — XRD pattern of the gilding sample showing various elements on the surface.

standard data JCPDF file No. 892838. However, the peaks of Au oriented along the (111) and (220) direction are found to be in good agreement with standard data of JCPDF file No. 893697. Presence of carbon and silicon reflection peaks in the diffraction pattern may be in the form of contaminants from the environment. Detailed analysis of the diffraction data also revealed the existence of CuSO_4 (JCPDF file No. 721248) along (020) plane, γ CuCl (JPDF file No.811841) along (200) plane and CuCl (JCPDF file No. 822117). Presence of CuSO_4 and CuCl phases in the diffraction pattern may be due to the presence of sulphate and chloride ions as contaminants from the environment and responsible for the corrosion or degradation in the form of pits on the surface of the gilding sample.
