Dynamic failure behavior of glass/epoxy composites under low temperature using Charpy impact test method

Mahmood M Shokrieh^{a*}, Mohammad A Torabizadeh^b & Abdolhossein Fereidoon^b

This paper demonstrates results of an experimental study on glass/epoxy laminated composites subjected to low velocity impact at energy levels equal to 10, 15 and 30 J under variable temperatures in the range of -30°C to 23°C. The configuration of specimens is quasi-isotropic. The low temperature and its influence on the maximum absorbed energy, elastic energy, crack length and delamination are highlighted. Also, the effects of geometry index (span-to-depth) and notch orientation are studied. Failure mechanisms of specimens are examined using microscopic examinations. Results indicate that impact performance of these composites is affected over the range of temperature considered. Failure mechanism is changed from matrix cracking at room temperature to delamination and fiber breakage at low temperatures.

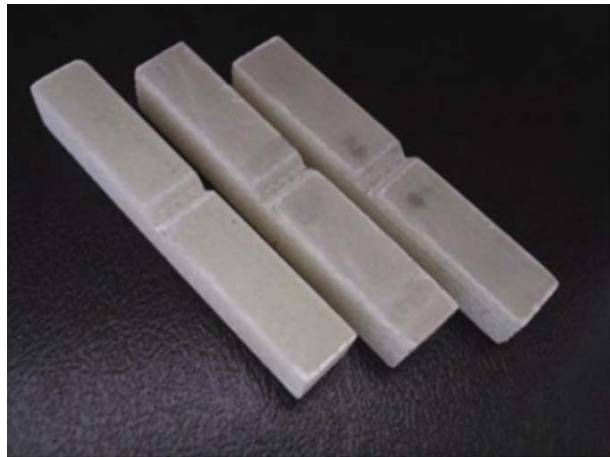
Fig. 3—Samples of fabricated specimens for Charpy impact test

and with different span length-to-depth ratios is prepared by a milling machine. The geometry of the specimen is shown in Fig. 2. The fiber volume fraction of the composites was evaluated experimentally after fabrication and found to be 65%. Figure 3 illustrates the prepared typical test sample for the impact tests.

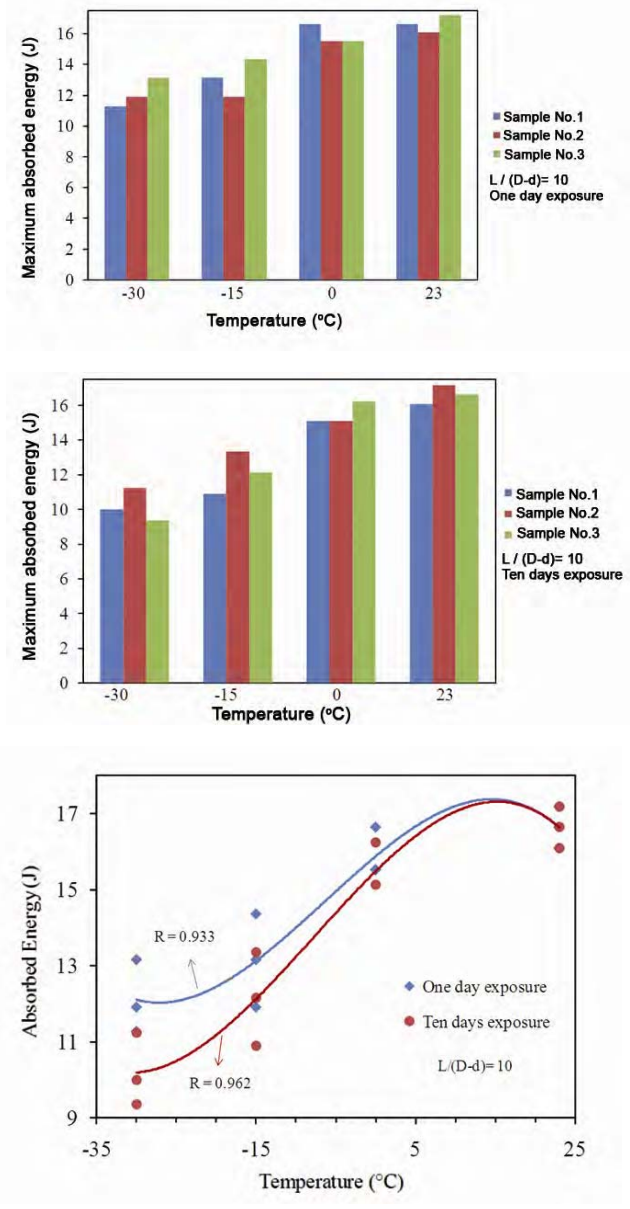
Fig. 7—Absorbed energy of impact test versus temperature for geometry index of 10

Fig. 5-8 show data for the absorbed energy by the specimens during the test for effective span-to-depth $L/(D-d)$ ratios of 6, 8, 10 and 12, respectively. Where D is the depth of the specimen and d is the notch depth. The data are measured with side-on notch orientation at various test temperatures after one and ten day exposure time. In each case, by a polynomial curve fitting to experimental data, the trend of absorbed energy by temperature changes is shown. Also the values of R (the correlation coefficient) are given to show acceptable scatter of the tests. As shown in figures, by decreasing temperature from room temperature, the difference between absorbed energy for two test cases was increased. It can be derived that after 10 day exposure at -30°C, and at the room temperature, the absorbed energy has the lowest and highest values, respectively for all test cases. As temperature decreases, internal damage area decreases significantly. A mechanical property that is sensitive to the deformation characteristics of the composite is

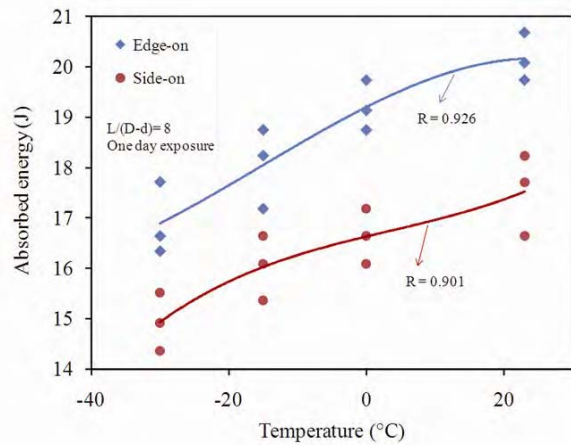
Fig. 10—Absorbed energy as a function of temperature for edge-on and side-on notch orientations

Fig. 10 shows data for the total energy absorbed by specimens during the test. The data are measured for specimens with edge-on and side-on orientations at test

temperatures varying from -30°C up to 23°C . The total measured energies show an increasing tendency with increasing the temperature. This general tendency results for both notch orientations, namely edge-on and side-on notches, with the values for side-on orientations always being smaller than the values for edge-on orientations. The failure phenomenology of the specimens with different notch orientations is very different.

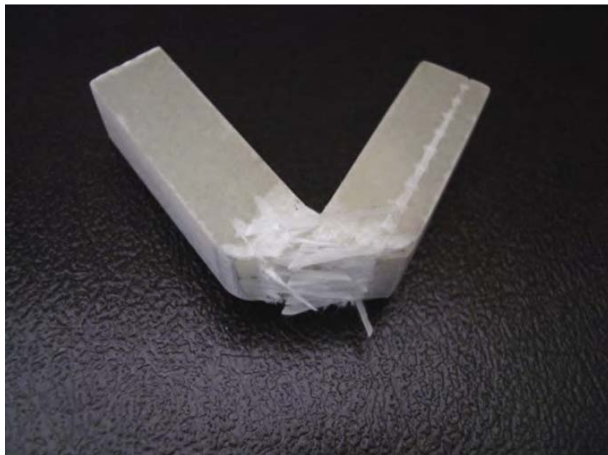
Fig. 11—Failure of a glass-epoxy specimen with edge-on oriented notch at room temperature

Fig. 11 shows a specimen with an edge-on oriented notch after the test. Failure takes place primarily along the glass reinforcements of the specimen. The matrix material is broken to a large extent and the glass fibers being extensively broken. The damage process is incomplete, it extends over a large portion of the glass reinforcements, but the two specimen halves are still held together by the remaining part of the fibers. The angle formed by the two halves of the broken specimen is larger than the angle the specimen had taken during the end phase of the test when being pushed by the striking hammer through the anvils (roughly 58° according to the given geometrical constraints). Thus, the specimen after the test bends slightly backwards towards its original shape.

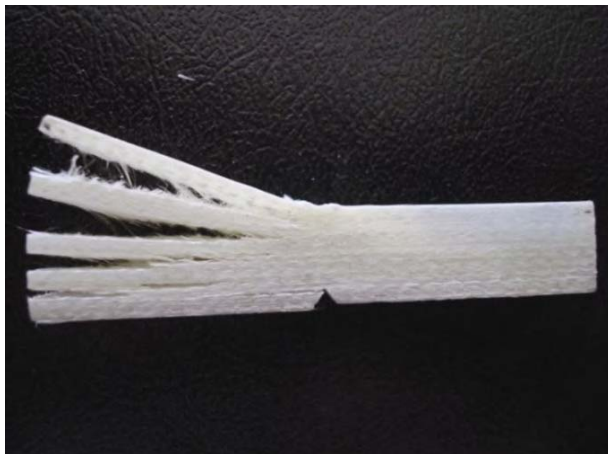
Fig. 12—Failure of a glass-epoxy specimen with side-on oriented notch at low temperature

Figure. 12 shows a specimen with a side-on oriented notch after the test. Failure in this case does not take place along the glass reinforcements of the specimen. Instead, in all cases, delamination failures of the specimens are observed in one side of the specimens. The matrix material fails along the weak interface planes between the plies of glass fiber reinforcements.

Shear stress due to geometrical constrains at large bend angles of the specimen cause the delamination failure type. Delaminated parts near the compressive side of the specimen show breaking of the glass fiber

reinforcements near the contact area of the impacting striker with the specimen. In some cases, the specimen broke off completely and the delamination is larger at the impact side of the specimen. However, no effects of fiber breakage in the notch tip area under the influence of tensile stresses are observed at room temperature. The specimen after the test tends to resume its original straight position and almost completely bends backwards with the delaminated parts remaining deformed to a certain extent. On the other hand, failure in the case of side-on notch orientations is caused by fracturing of the matrix material along the weak interface planes between the plies of laminates and fiber breakage is of no or only little influence. This difference in the influence of fibers on the failure process explains the observed larger values of the absorbed energy for specimens with edge-on notch orientations compared with the equivalent data for side-on notch orientations. Figure. 13 shows sample of the fractured glass/epoxy specimens after impact testing temperature between -30 and 23°C.

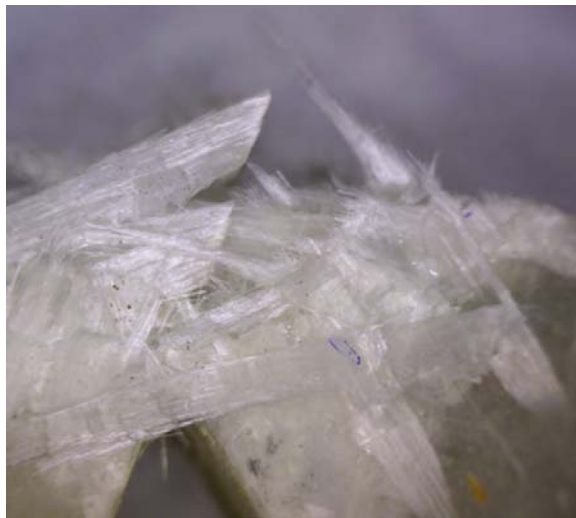
Fig. 15—Microscopic examination of fractured specimen with edge-on notch orientation after one day exposure at -30°C

Also, Fig. 15 shows a sample of the edge-on tested specimens at -30°C , when subjected to impact loading. In this case, failure concentrates on the glass reinforcements; glass fiber breakage under the influence of tensile stresses ahead of the notch is the most common failure mode. No delamination and matrix cracking was observed in edge-on tested specimens.
